**FINAL REPORT  
ROUND 10 DAM ASSESSMENT  
PPL GENERATION, LLC.  
BRUNNER ISLAND POWER STATION  
ASH BASIN NO. 6 WITH POLISHING POND, EQUALIZATION POND AND  
INCIDENTAL WASTE TREATMENT BASIN (IWTB)  
YORK HAVEN, PENNSYLVANIA**

**DECEMBER 20, 2012**

**GZA GeoEnvironmental, Inc.  
One Edgewater Drive  
Norwood, Ma 02062  
GZA File No. 01.0170142.30**

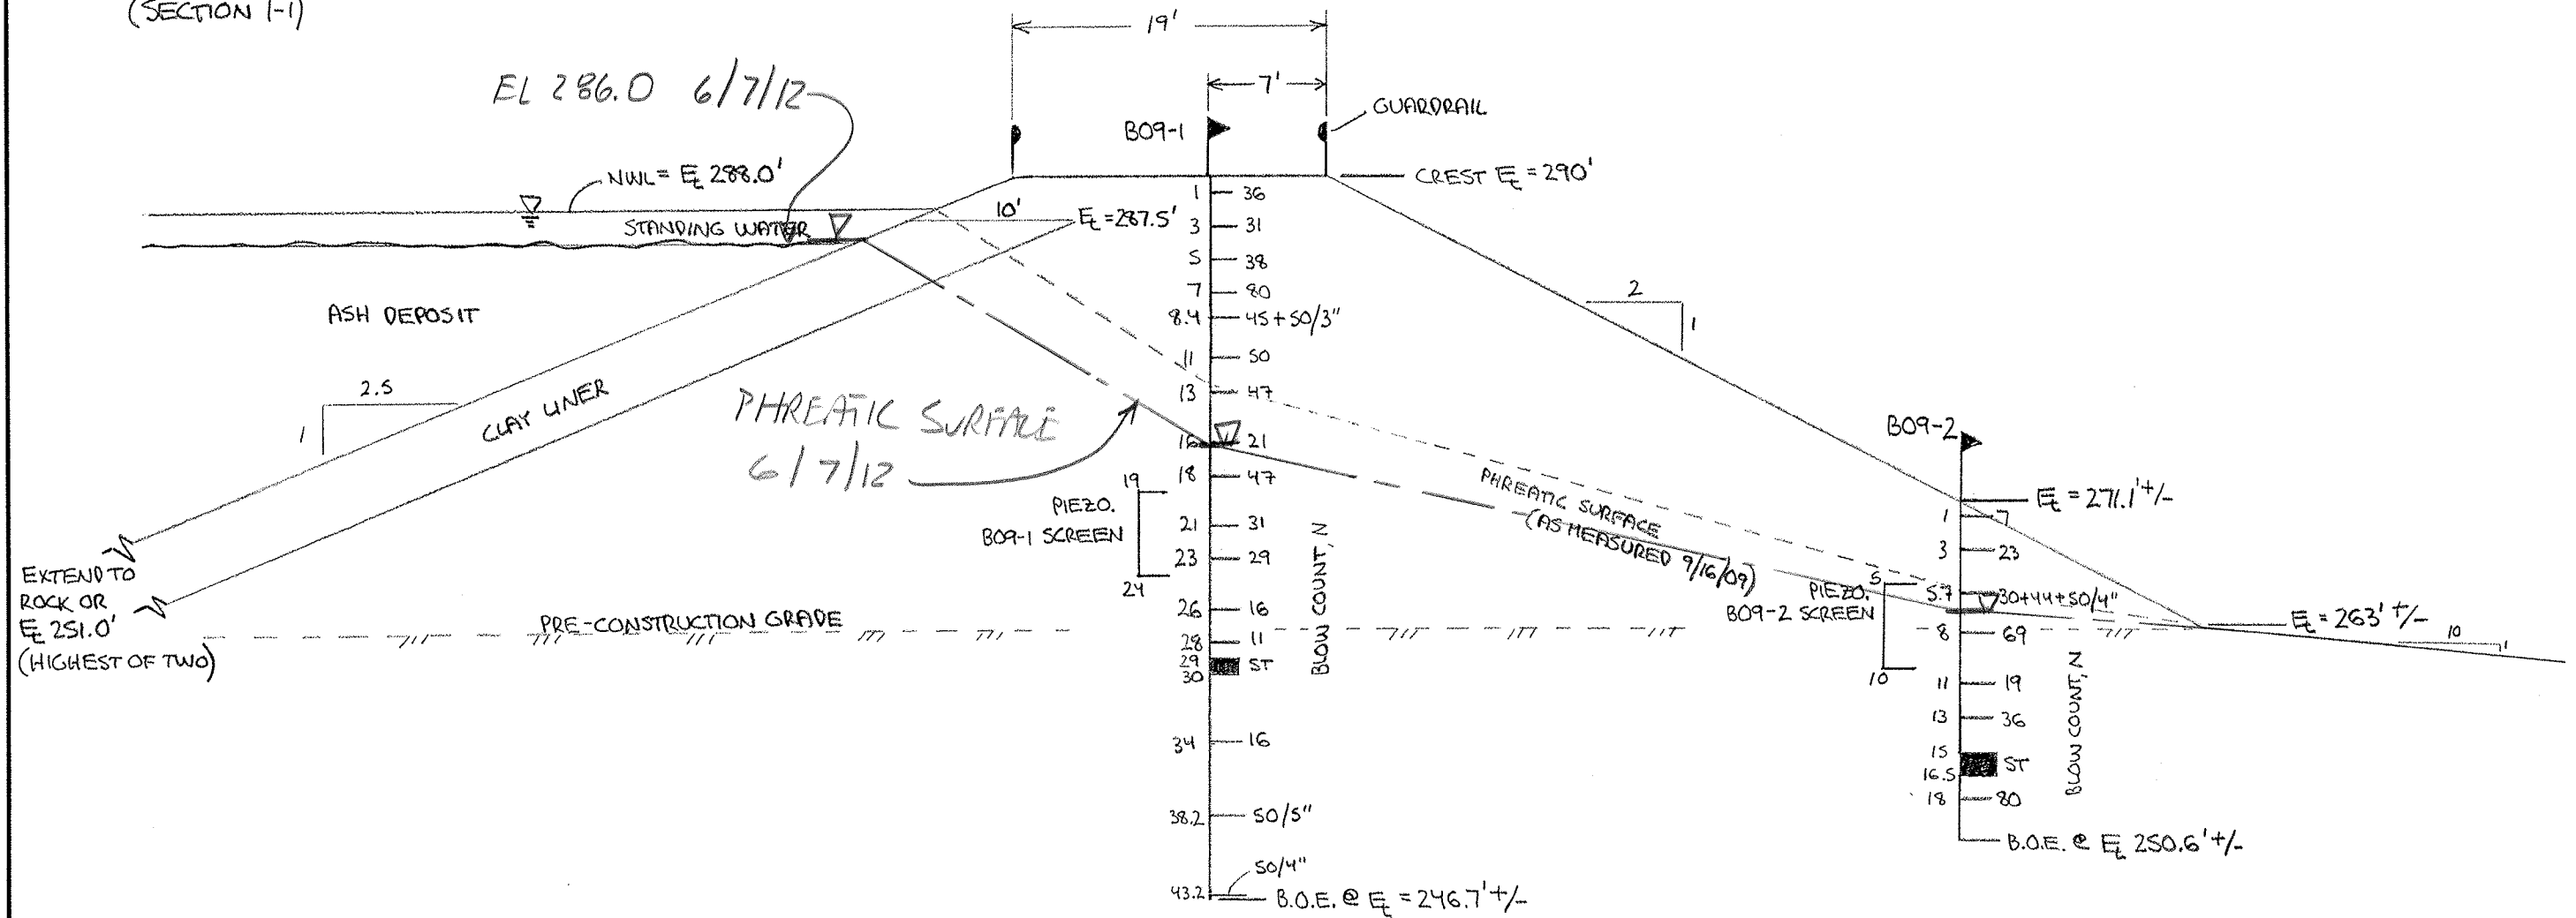
FIGURE 3

Variations in the phreatic surface were observed between the two cross sections in which piezometers were installed, as seen on Figures 2 and 3. It was apparent that the observed seepage at Station 7+44 was the result of an isolated permeable zone that was not reflected by the piezometers, or by capillarity or some other cause. The embankments were constructed with an

STATION 21+80 +/-:  
(SECTION 1-1)

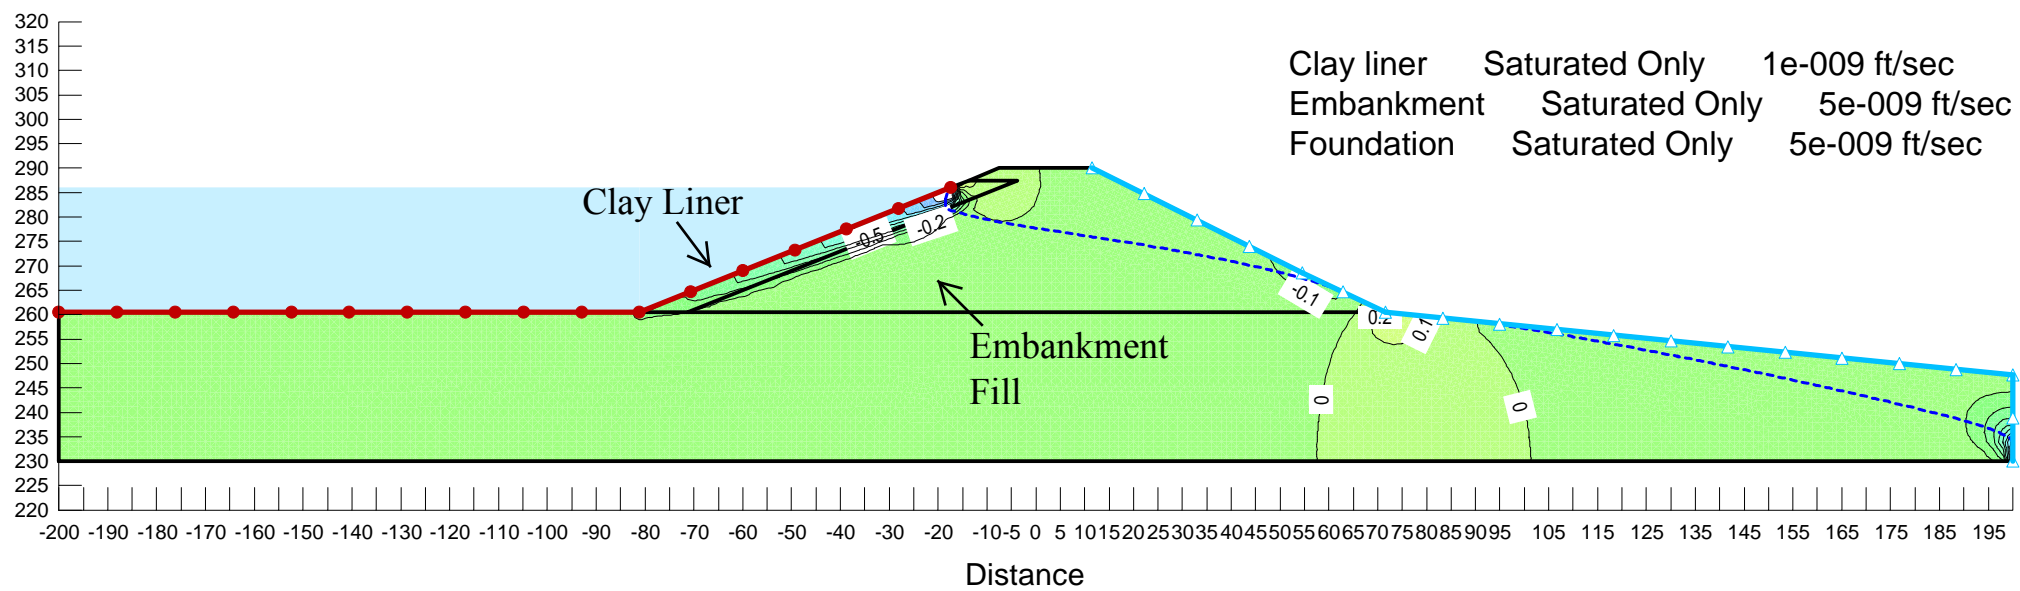
Figure 4  
 Clay Liner and Embankment Fill with  
 Similar Permeability  
 Vertical Seepage Gradient Plotted

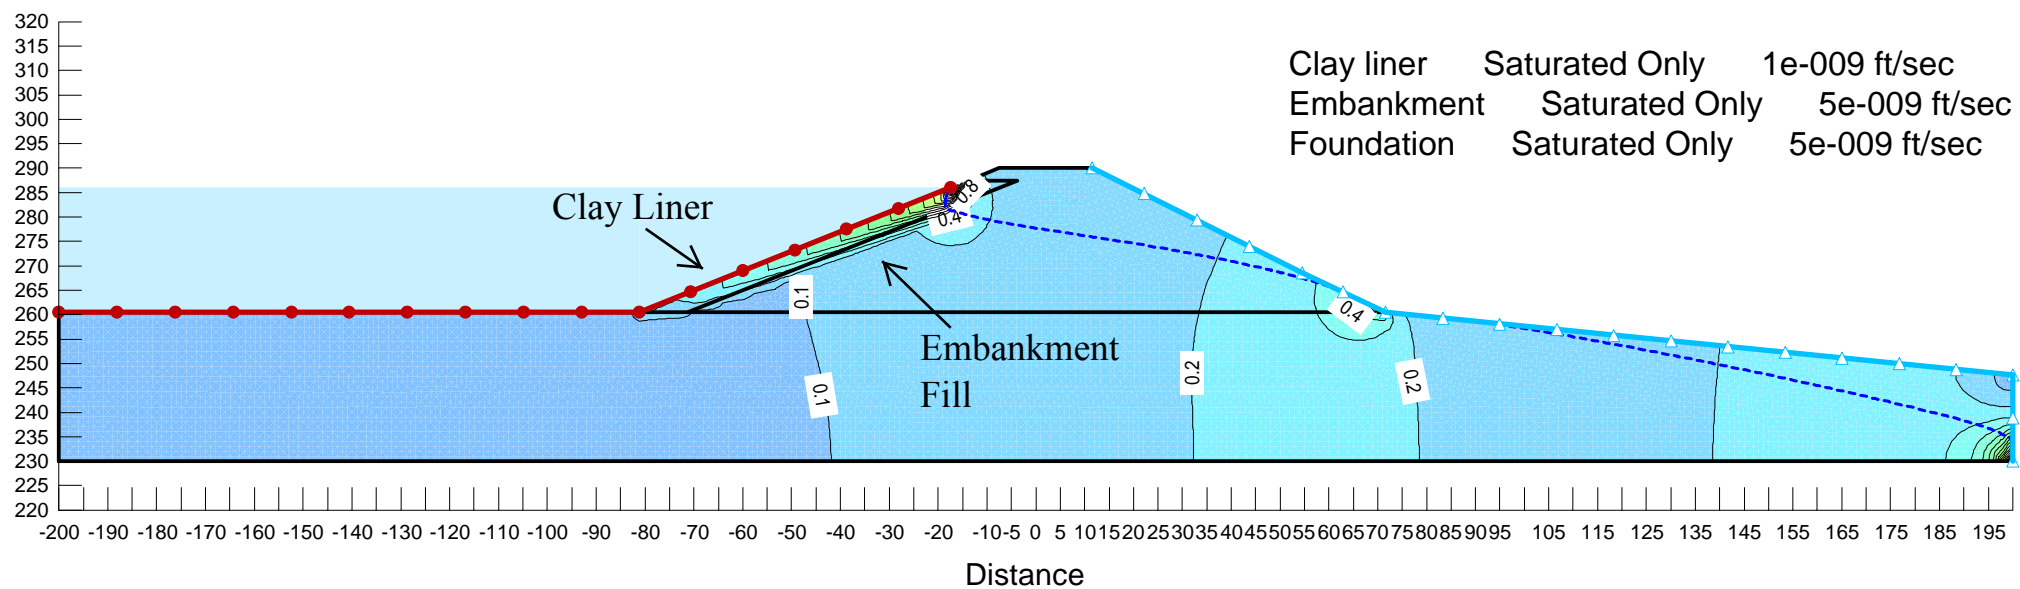
Figure 5  
Clay Liner and Embankment Fill with  
Similar Permeability  
X-Y Seepage Gradient Plotted

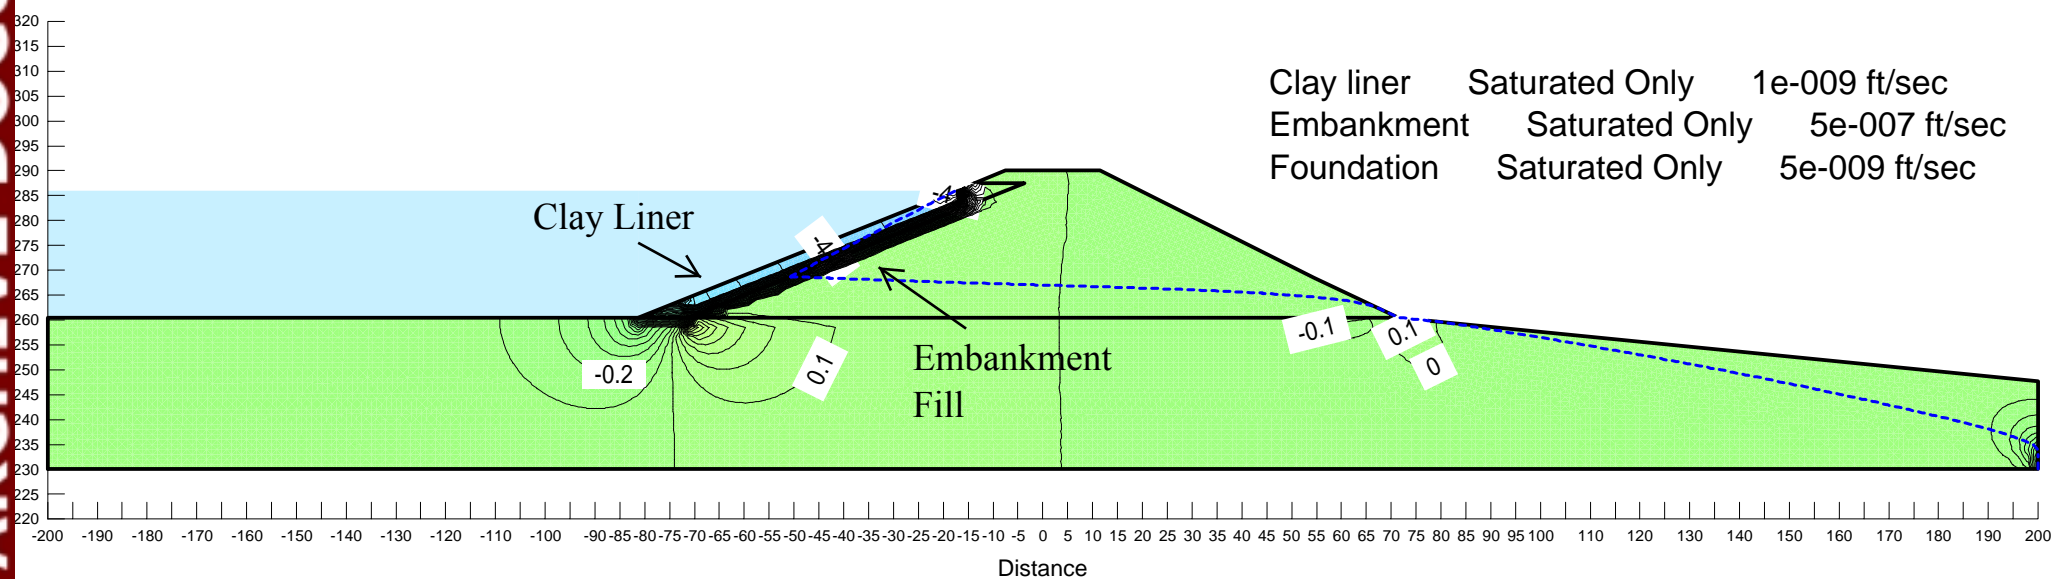
Figure 6  
 Clay Liner Permeability  $\ll$  Embankment Fill Permeability  
 Vertical Seepage Gradient Plotted

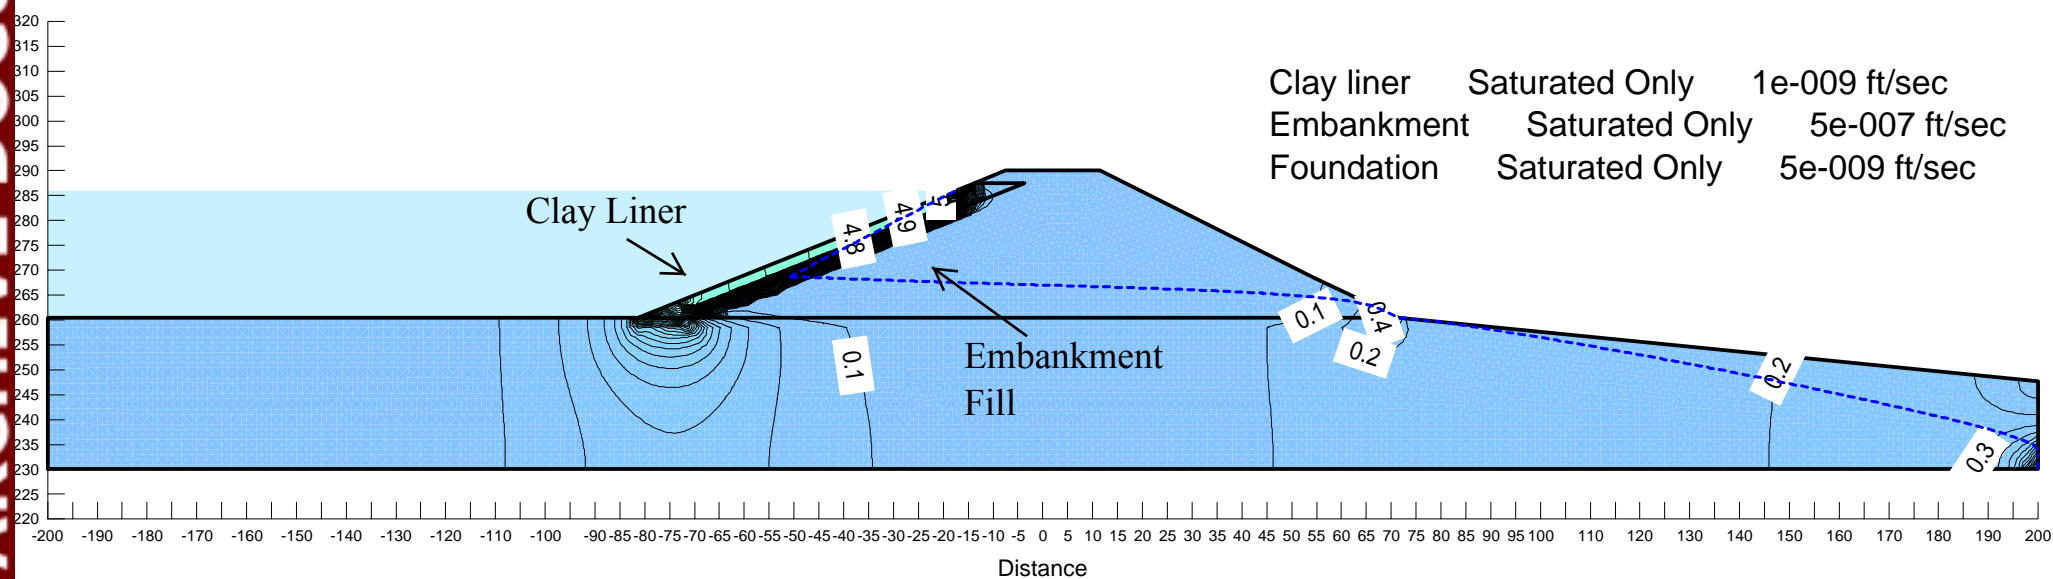
Figure 7

Clay Liner Permeability  $\ll$  Embankment Fill Permeability  
X-Y Seepage Gradient Plotted
